# **Chicago Metro Home Inspections**

## **Home Inspection Services**

7229 S. Hamlin, Chicago, IL 60629  
Inspection prepared for: John Doe  
Date of Inspection: 1/1/2016 Time: 2:30pm  
Age of Home: 19 Years Size: 2628 square feet  
Weather: 95 Sunny

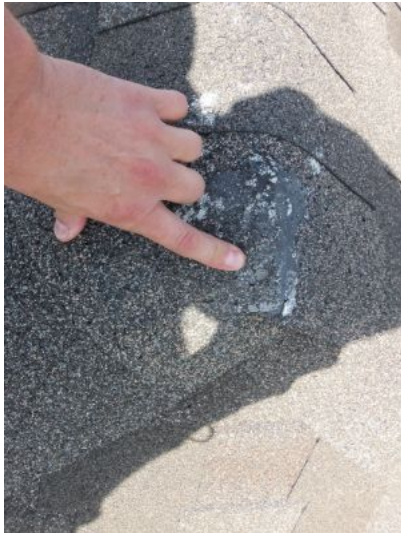
exposed roof nails

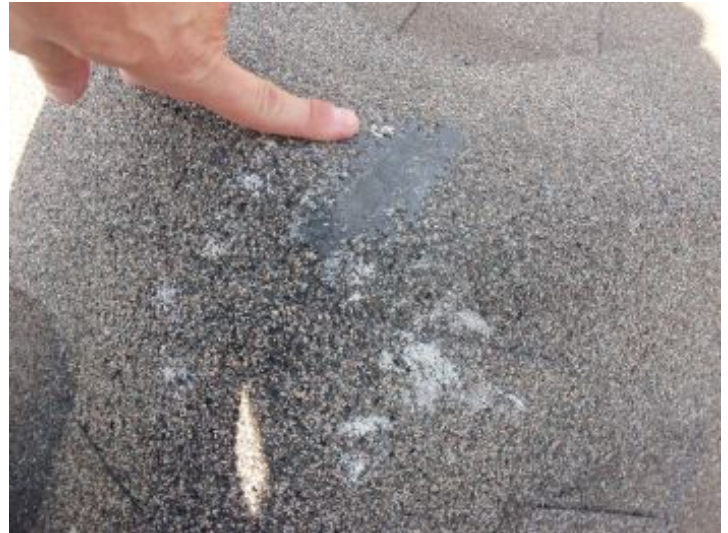
exposed roof nails

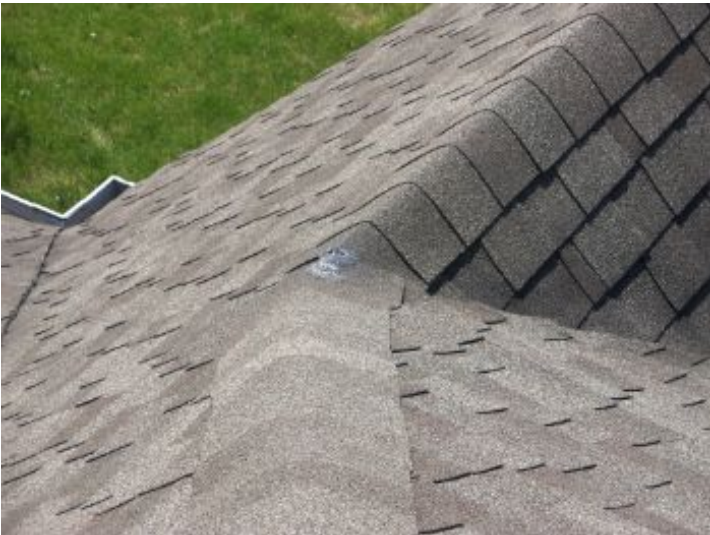
exposed roof nails

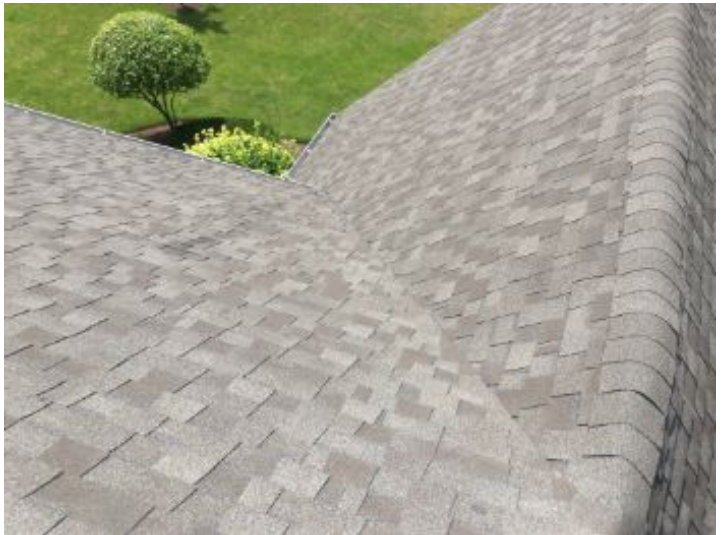
Appears Satisfactory

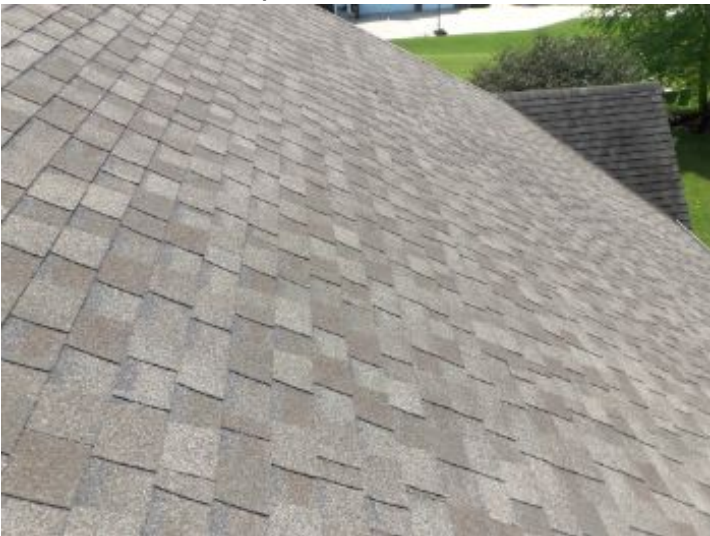
Appears satisfactory

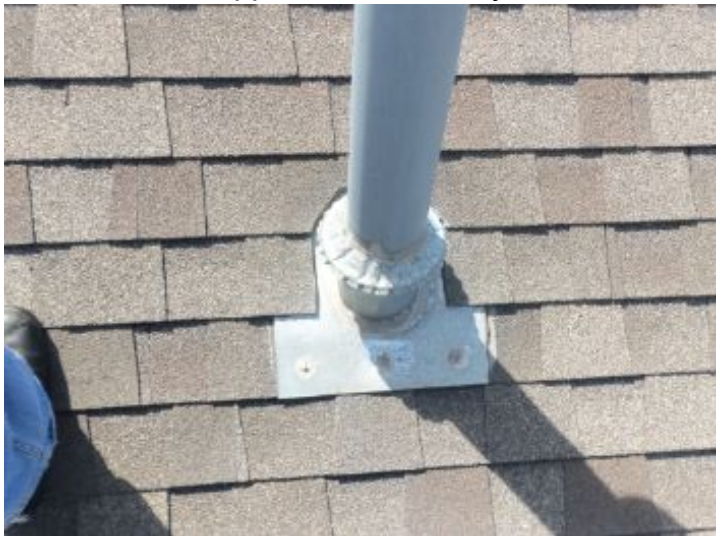
Flashing around Vent is satisfactory.

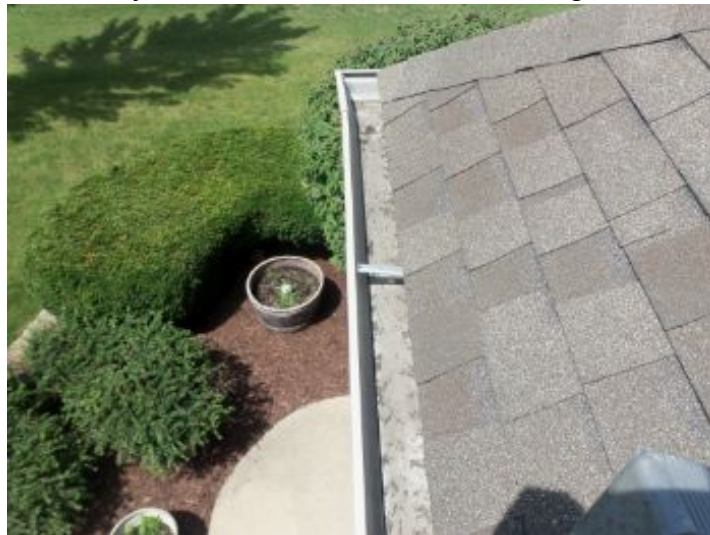
Minimal Granule loss.

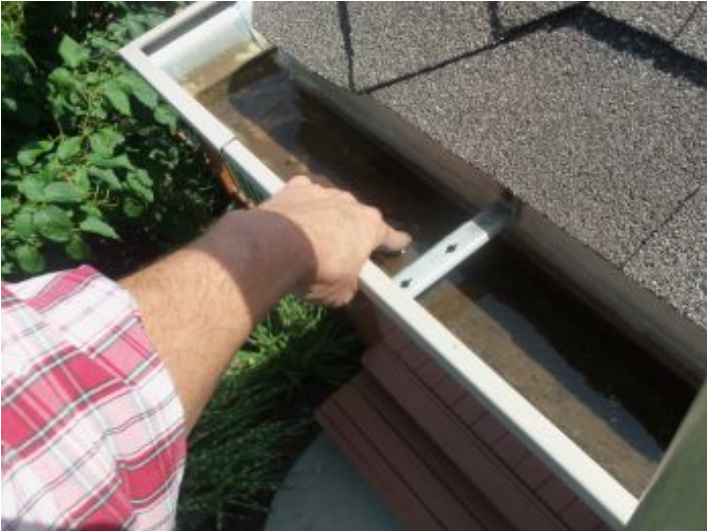
Standing water on NE gutters, due to clogged strainer.

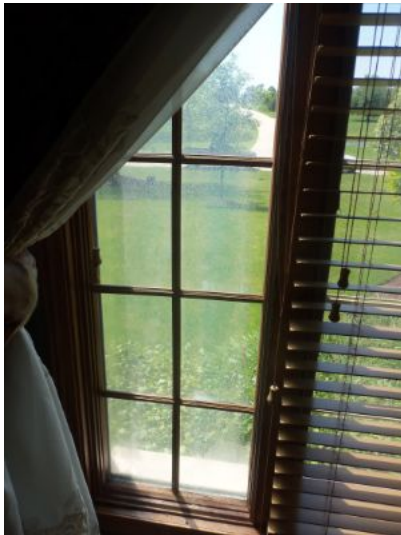
Office, main floor, window seal cracked, recommend repairing or replacing.

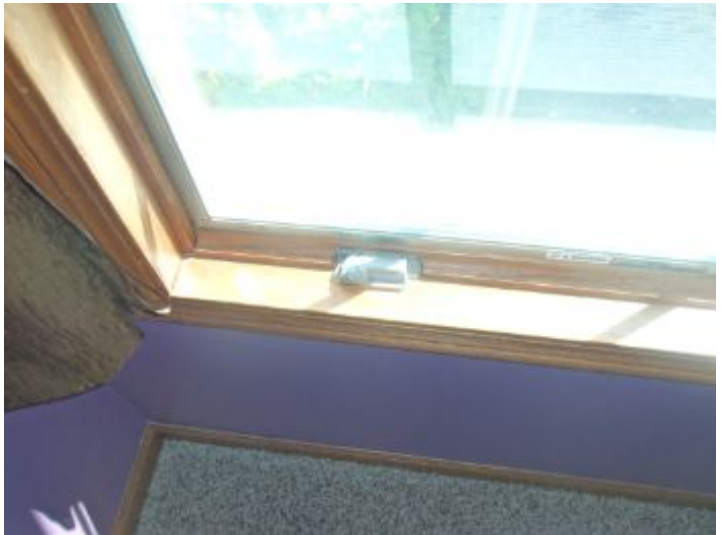
missing crank handles throughout the home.

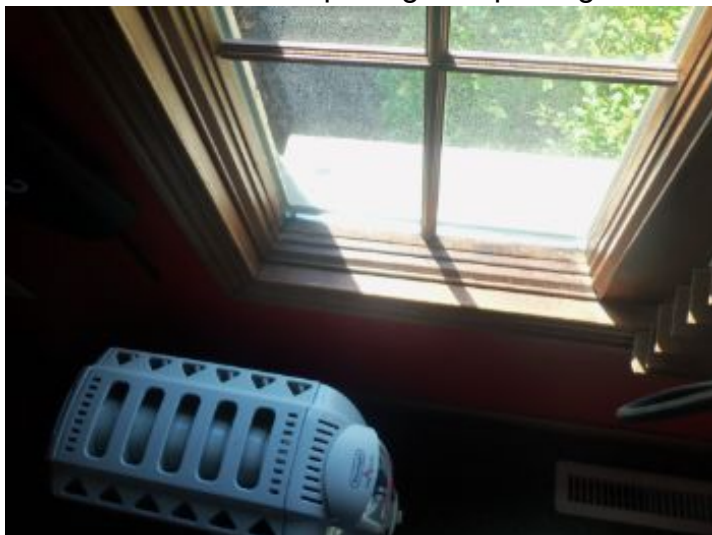
BD#1, window seal cracked, recommend replacing or repairing

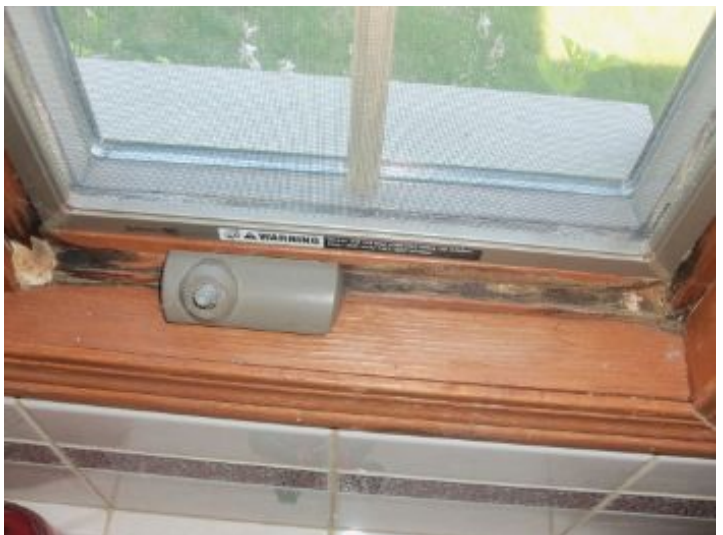
Master Bathroom, evidence of water / moisture on the window.

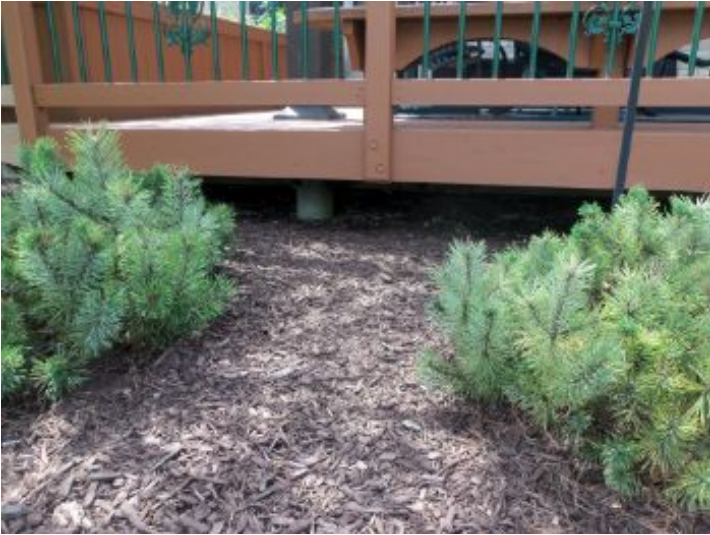
limited view

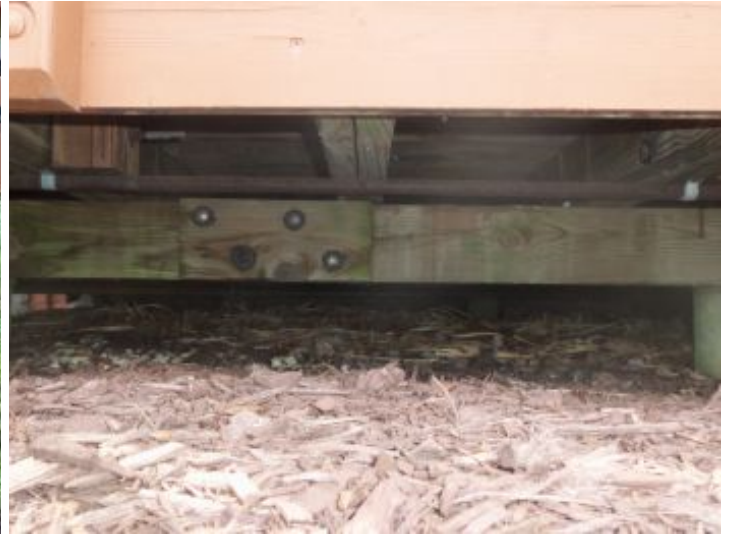
limited view

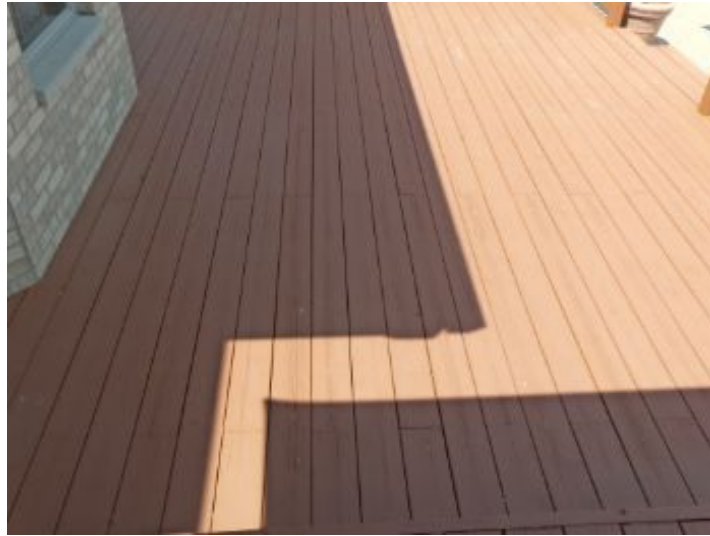
Proper spacing between blanks

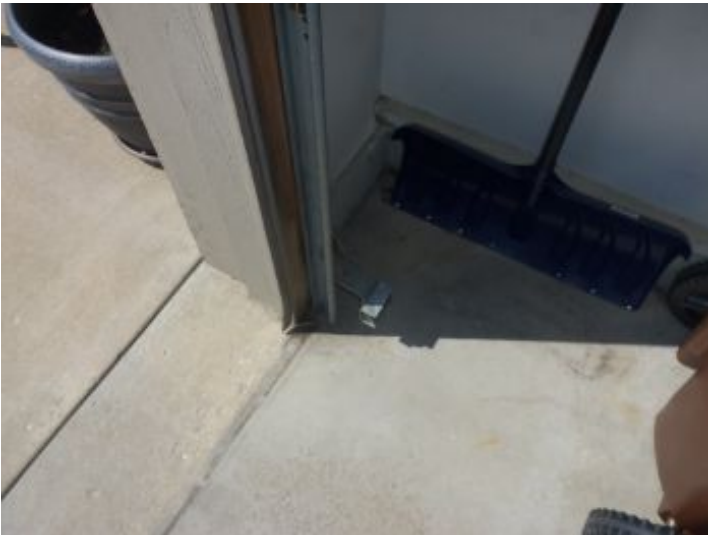
Garage photo eye properly functioning.

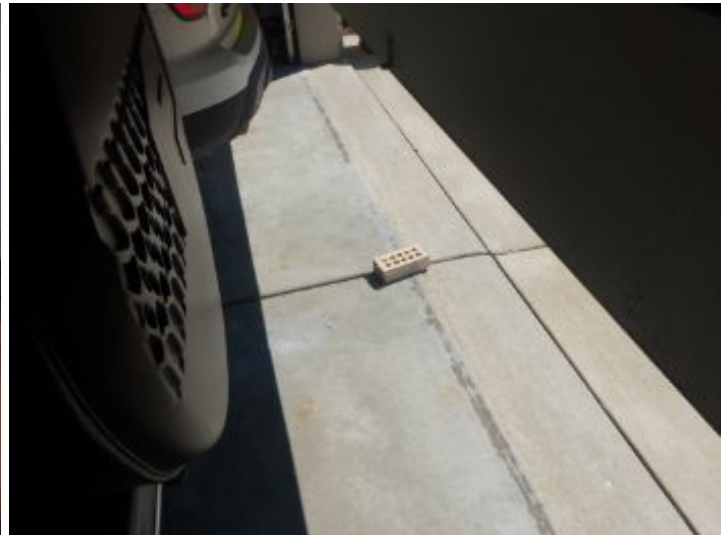
Garage Door reverse mechanism operates properly.

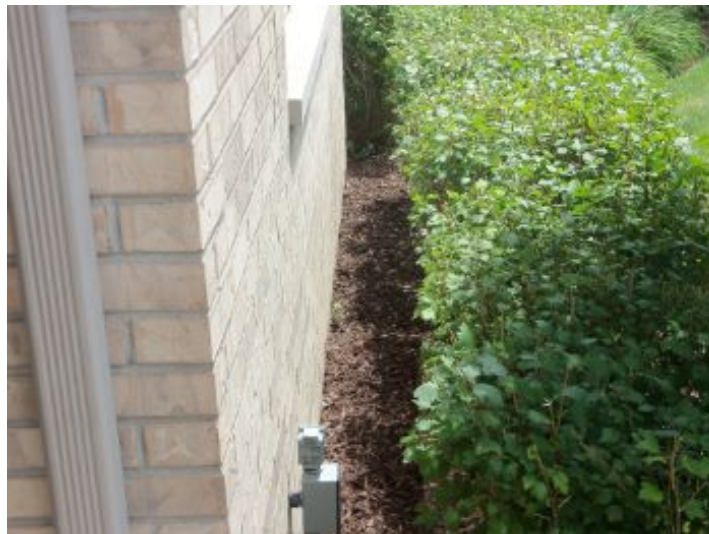
Foliage appears satisfactory

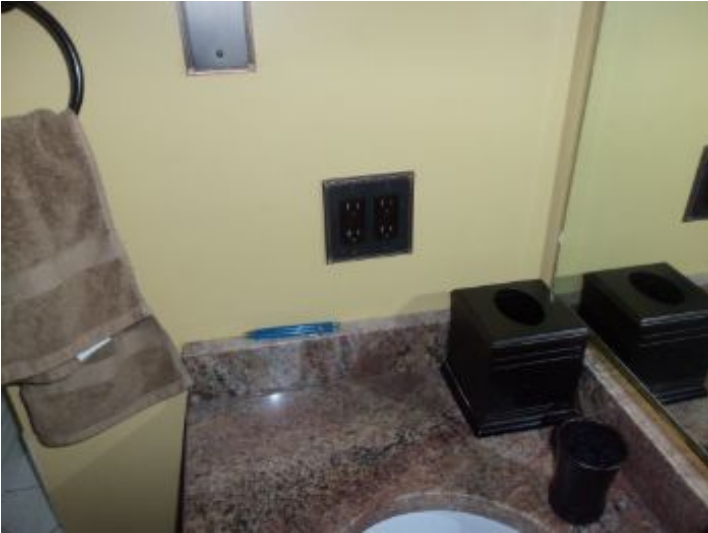
Missing GFCI in Master Bathroom.

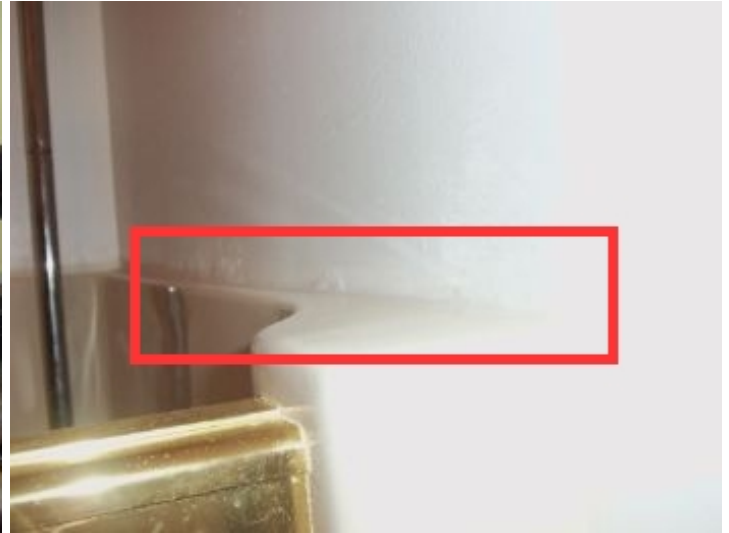
Master Bathroom / Shower, evidence of water damage to walls.

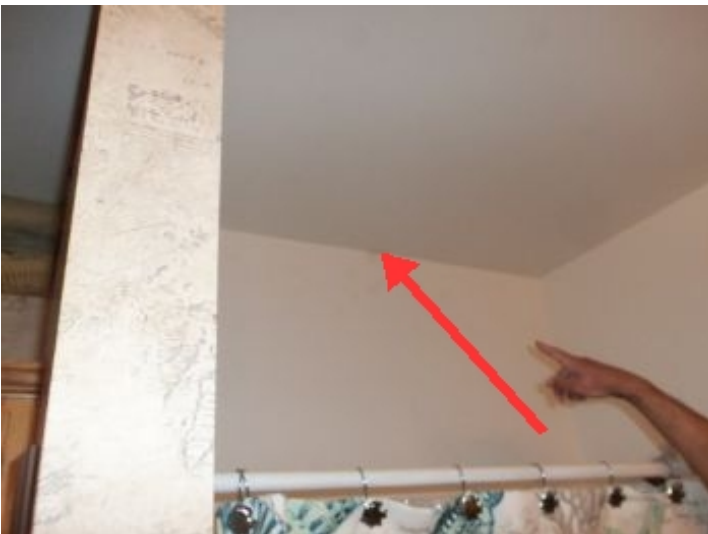
Evidence of water damage in the bathroom ceiling, recommend asking seller for an explanation.

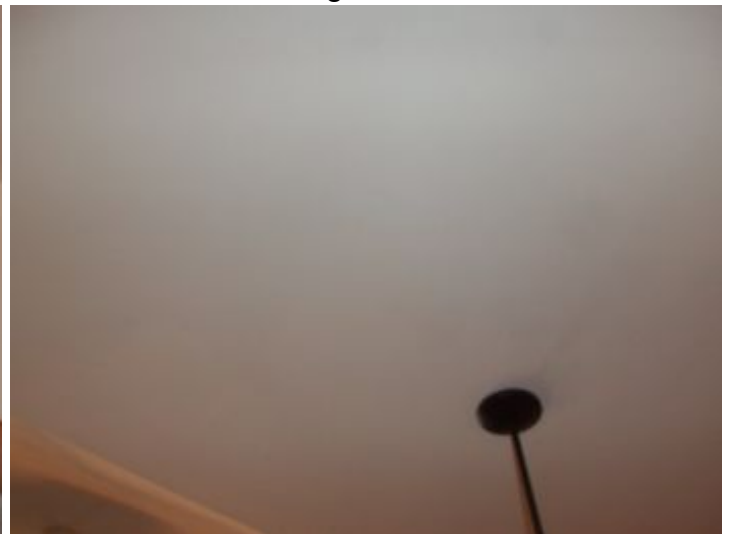
Evidence of possible water damage, front entrance ceiling, recommend asking seller for an explanation.

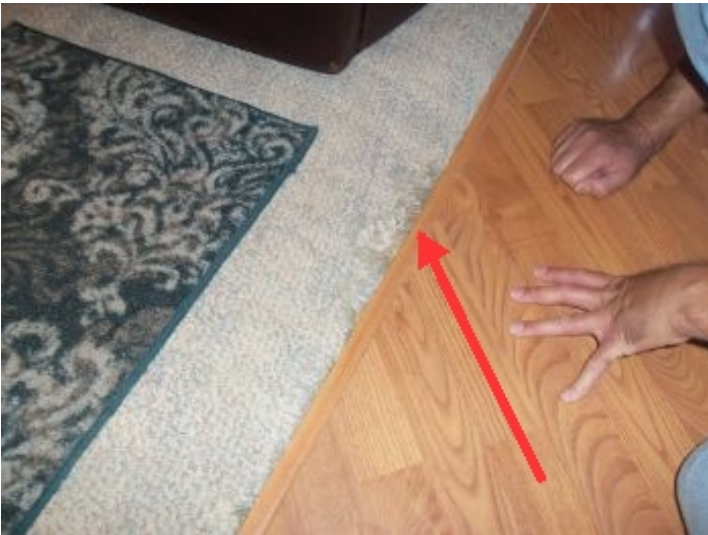
Carpet damaged.

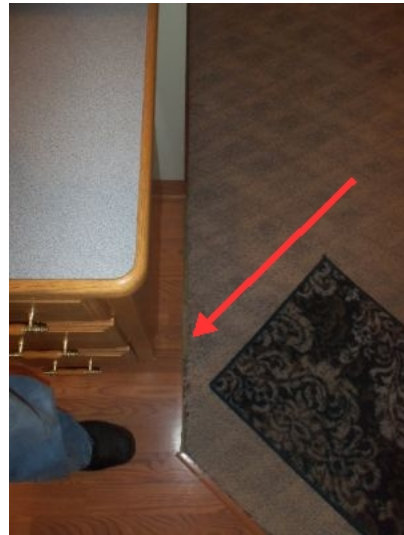
Carpet damaged.

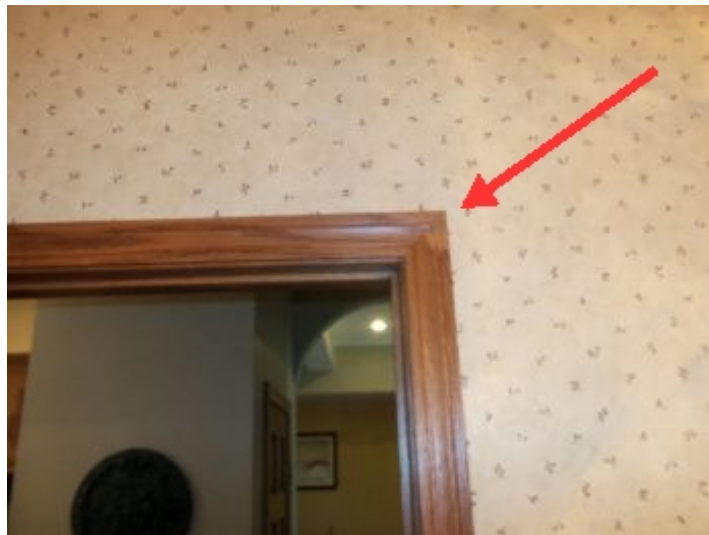
Damage to restroom trim.

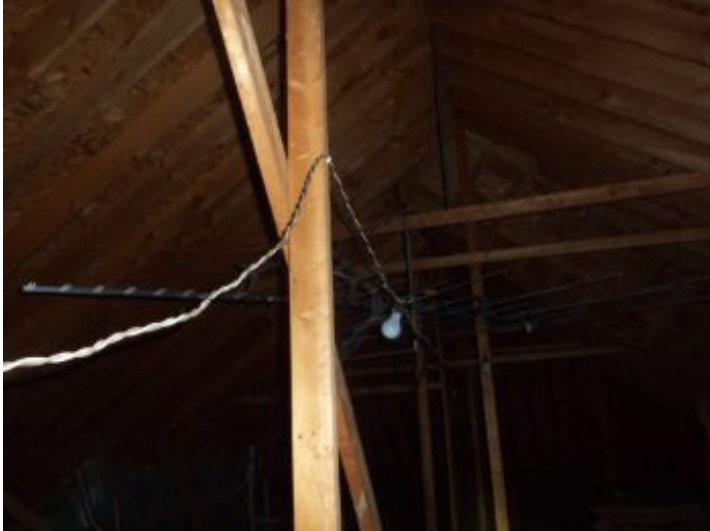
120 v exposed wire, recommend removing.

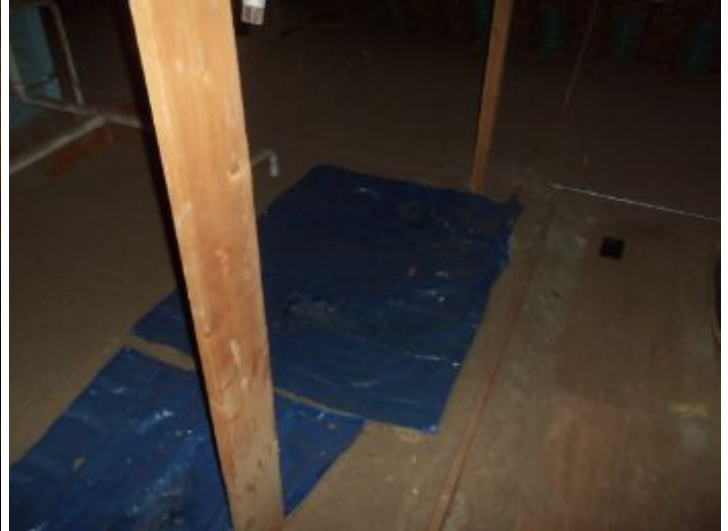
Tarps in the attic? recommend asking seller for an explanation.

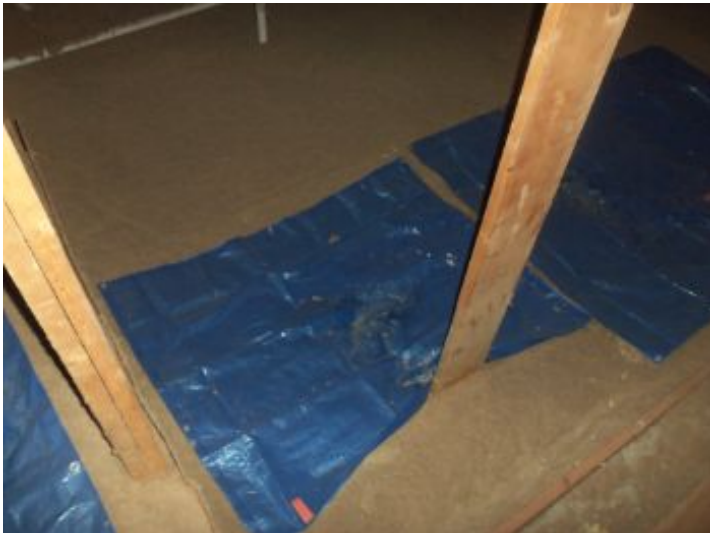
Tarps in the attic? recommend asking seller for an explanation.

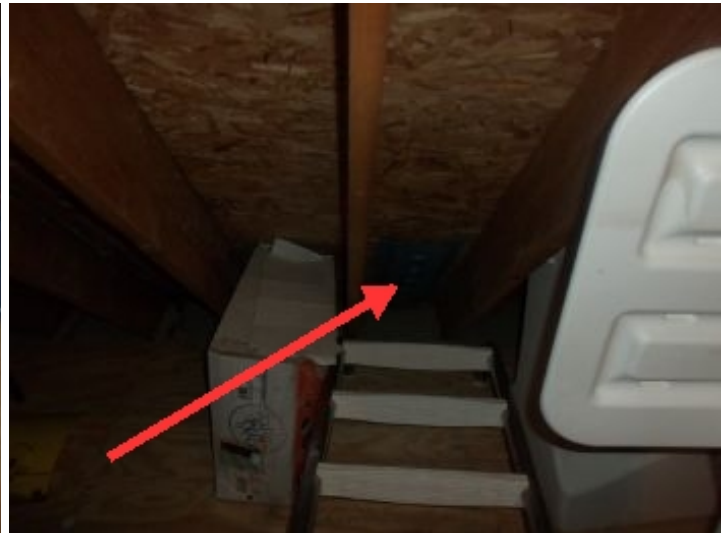
Proper venting installation , Baffles installed.

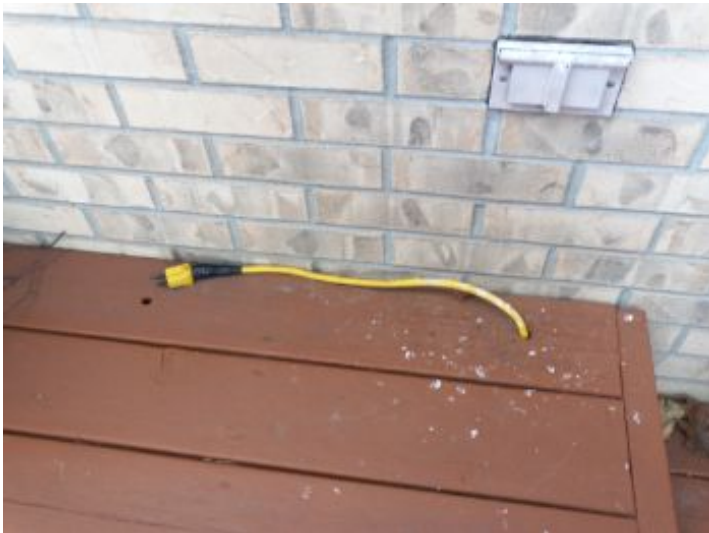
Possible tripping safety hazard. unknown where this leads to?

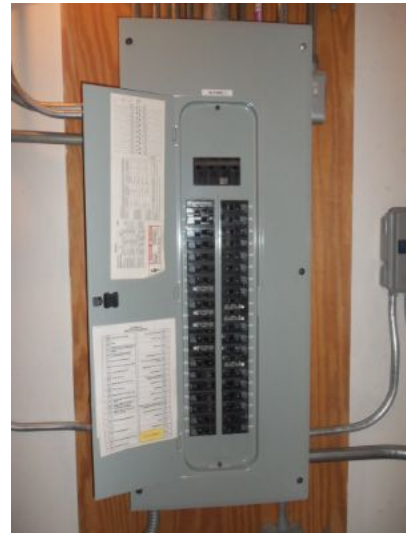
200 campo service, located in the basement. All breakers labeled

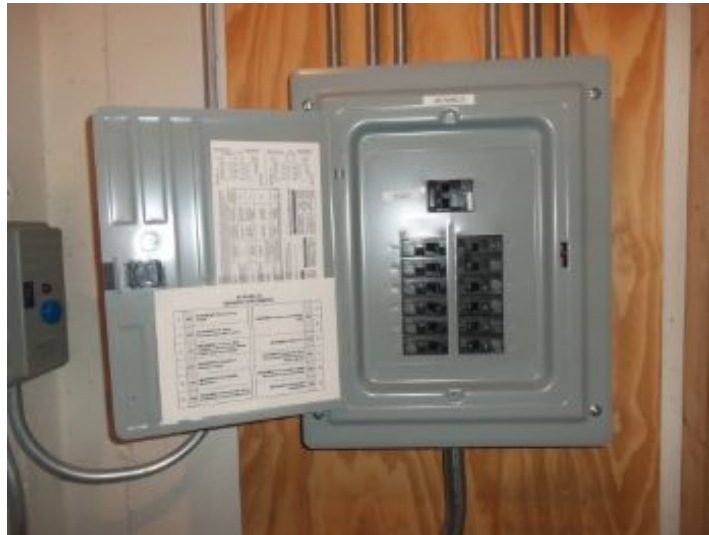
100 amp sub panel, all breakers labeled

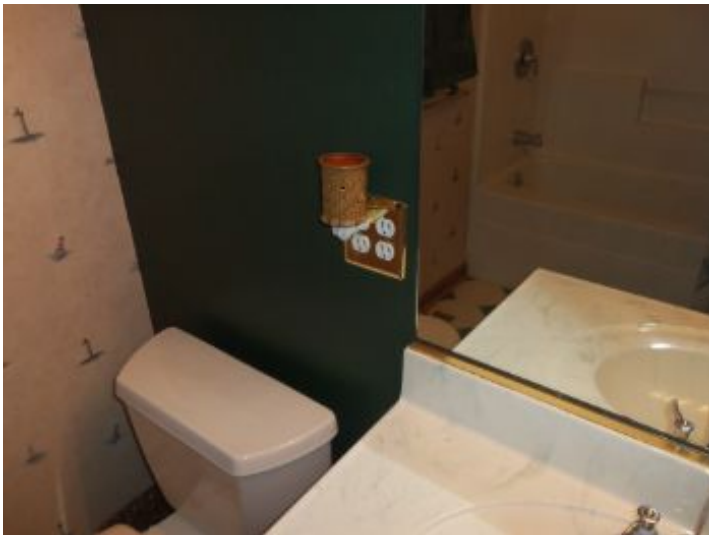
No GFCI

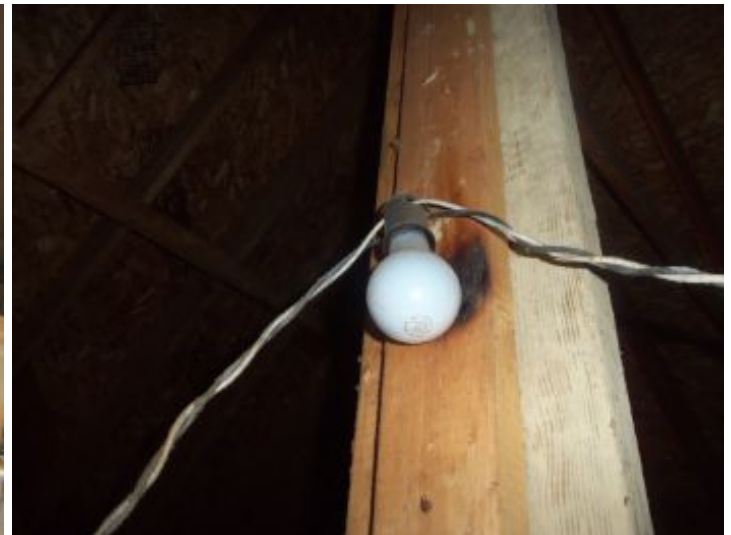
Incaadesant bulb creating a fire hazard, recommend removing or installing a globe.

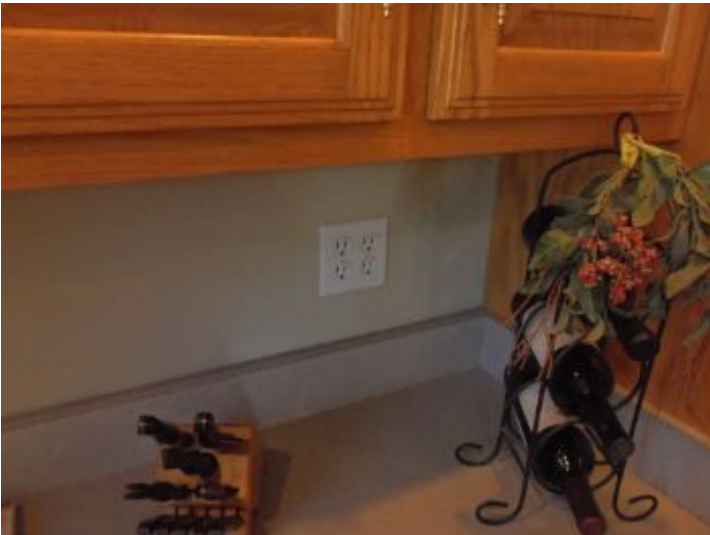
Kitchen, No GFCI present, recommend replacing all outlets with GFCI.

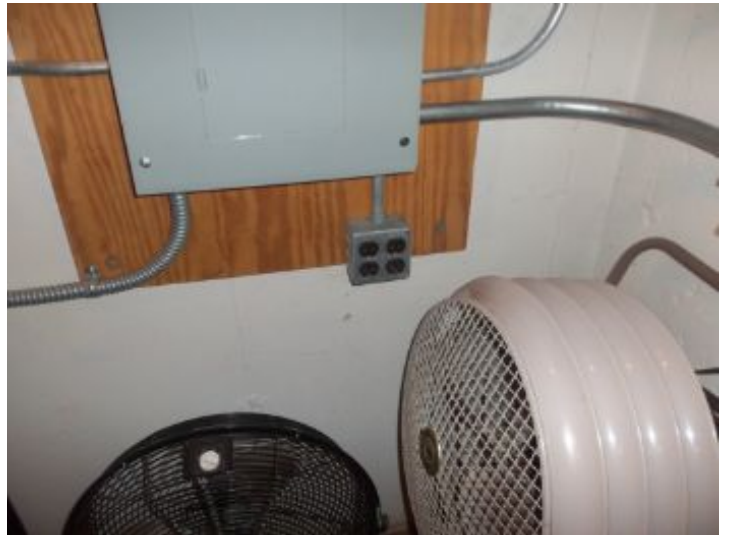
Missing GFCI in the Basement

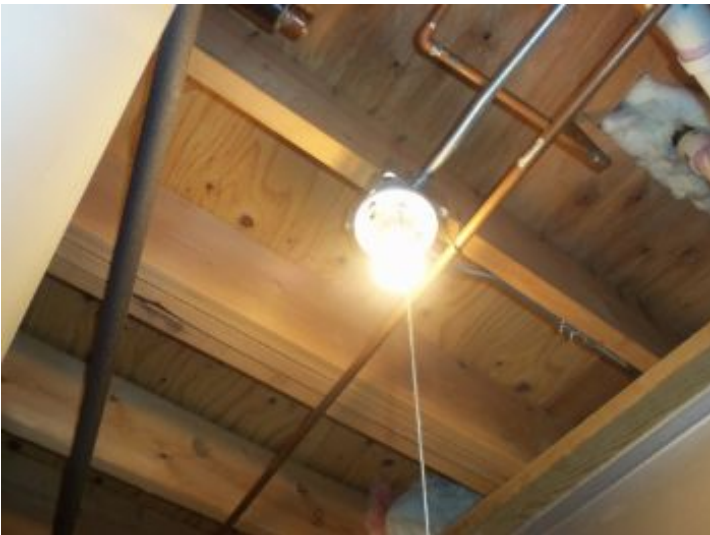
Missing Globes in the basements closets.

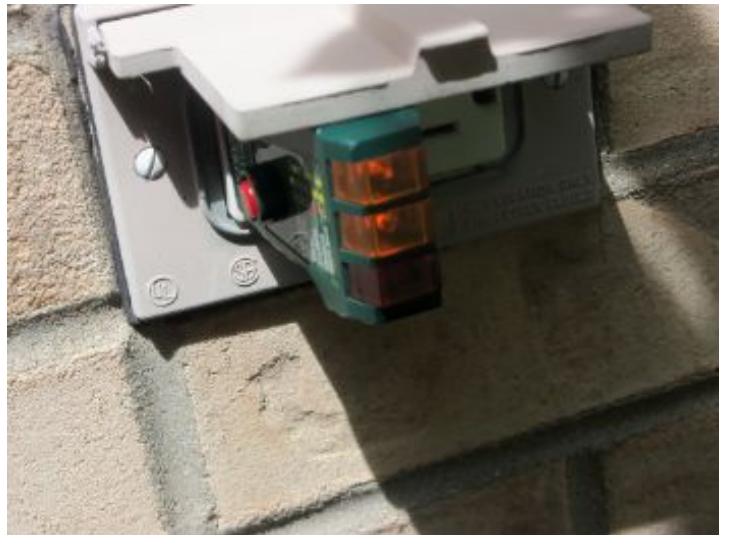
Outside GFCI operates.

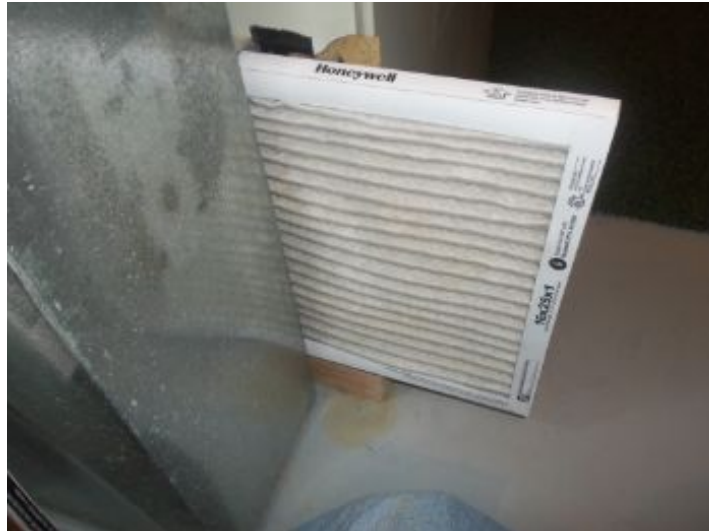
Furnace Filter clean.

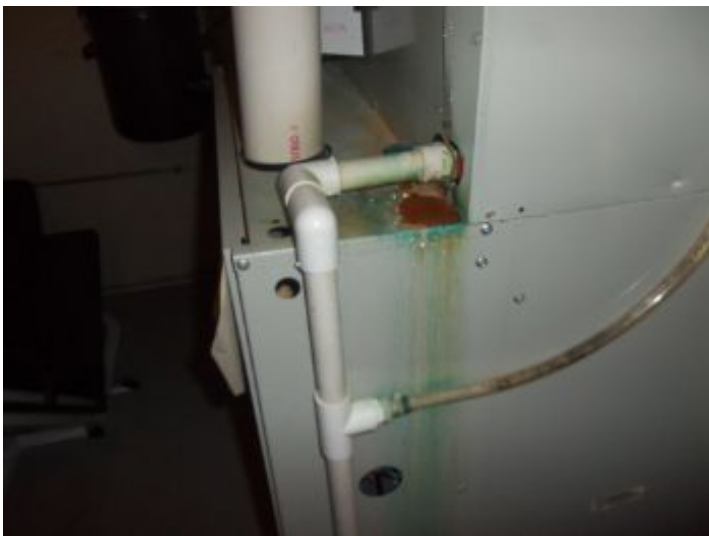
Condensate leaking from the furnace, recommend repairs.

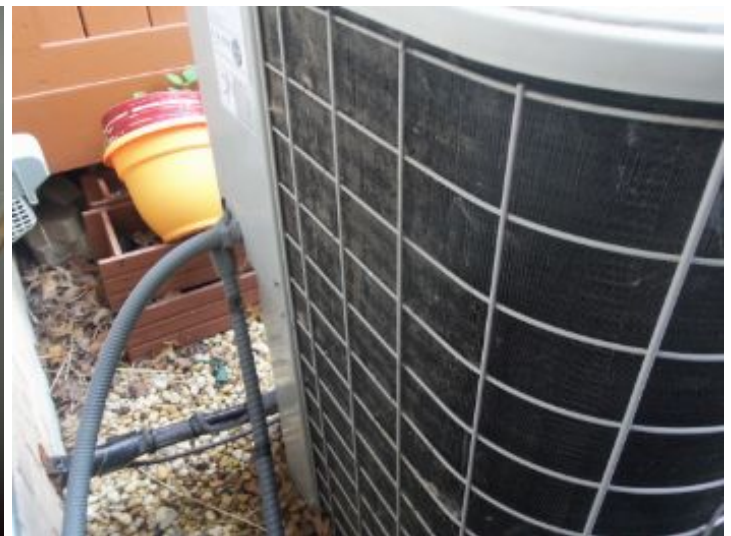
Cleaning required on the back side of the Air Conditioner.

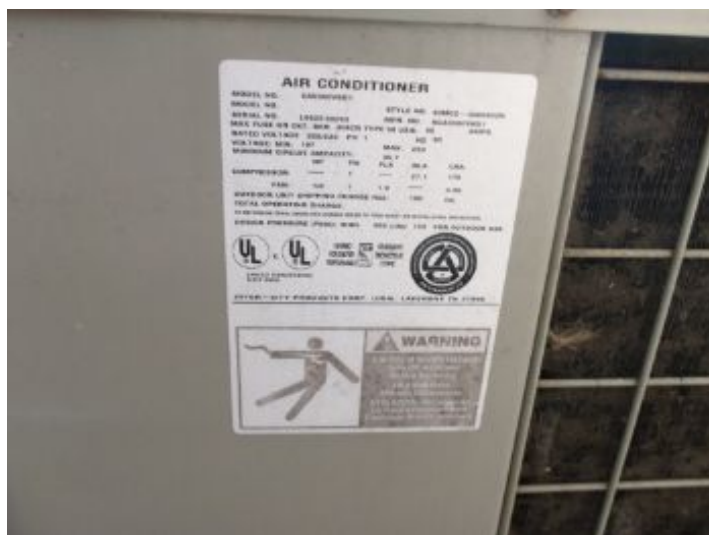
Air condenser, Manufactured in 1996, units operates as designed.

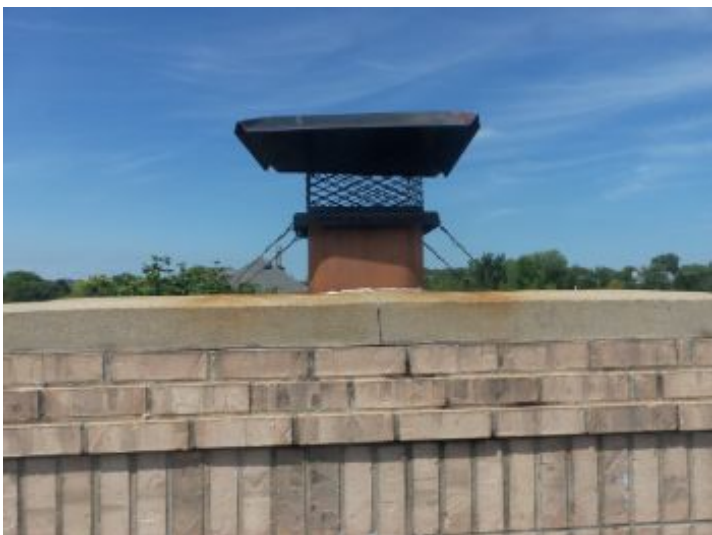
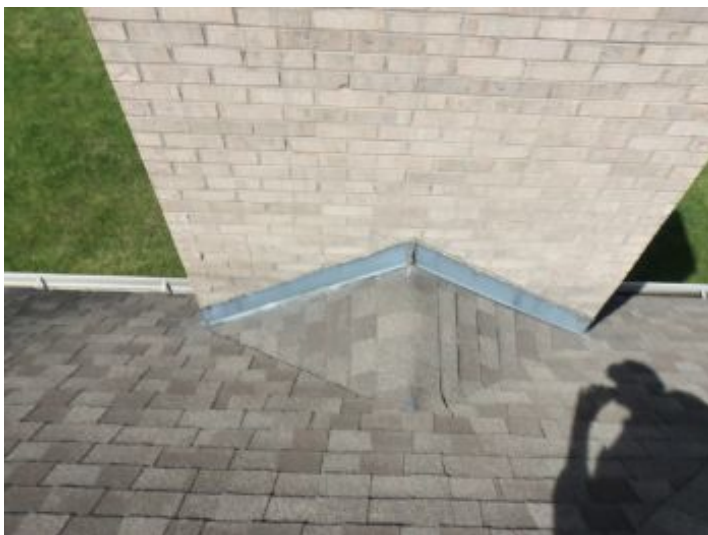
Chimney Cricket installed properly

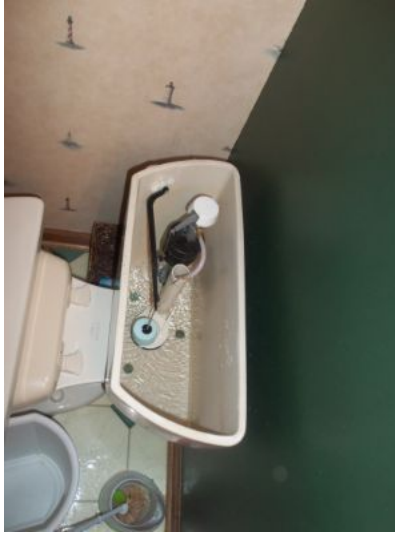
Bathroom, 1 st. floor, Flush valve stuck, recommend repairs or installing new valve.

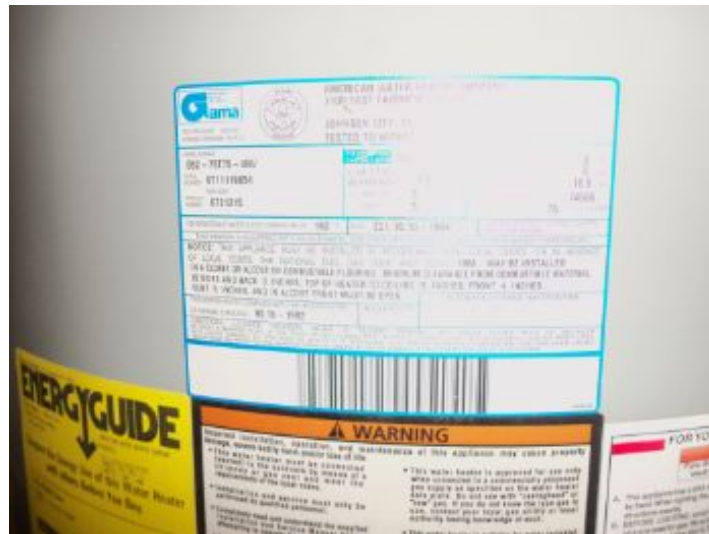
Manufactured in 1997, nearing its life expectancy. Operates as required, temps at 120F

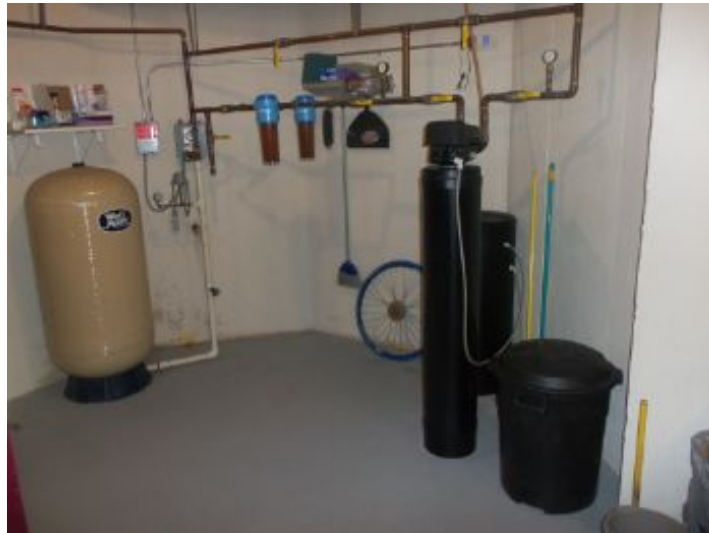
Water Softner System, observed to be piped correctly.

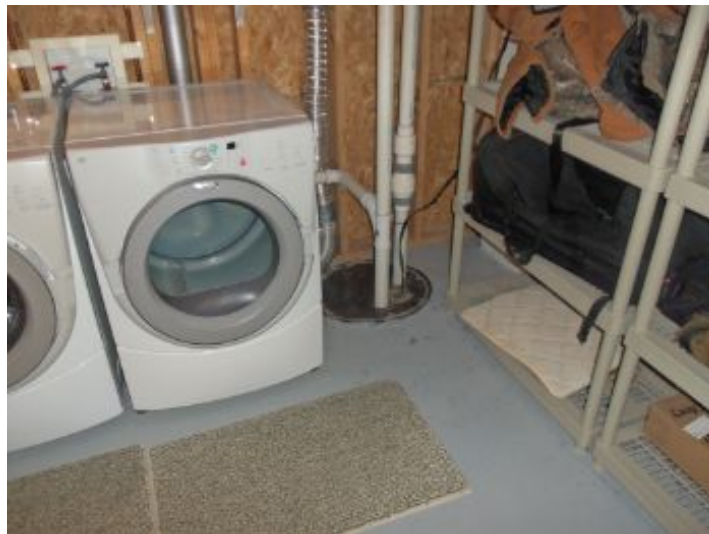
Observed to be piped correctly.

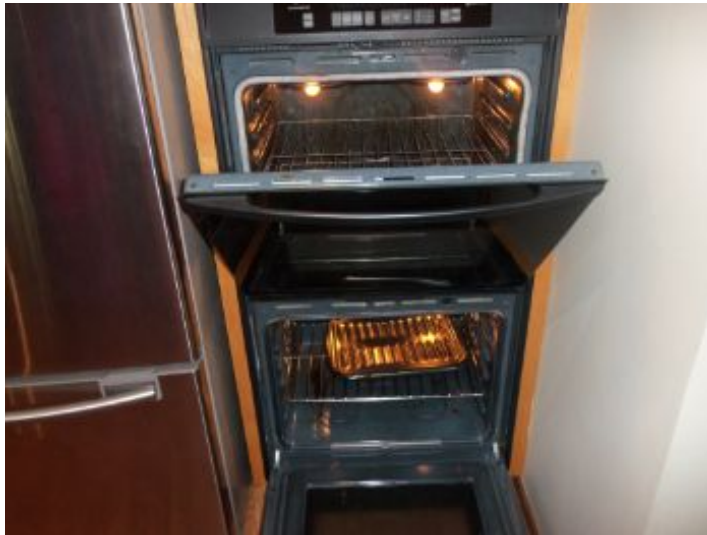
Operates as designed.
