# **Chicago Metro Home Inspections**

## **Home Inspection Services**

12345 S. Park way Ave, Chicago, IL 60629  
Inspection prepared for: Sample  
Date of Inspection: 2-14-2016 Time: 2:00pm  
Age of Home: 1953 Size: 986 Sq Ft  
Weather: 90F Sunny

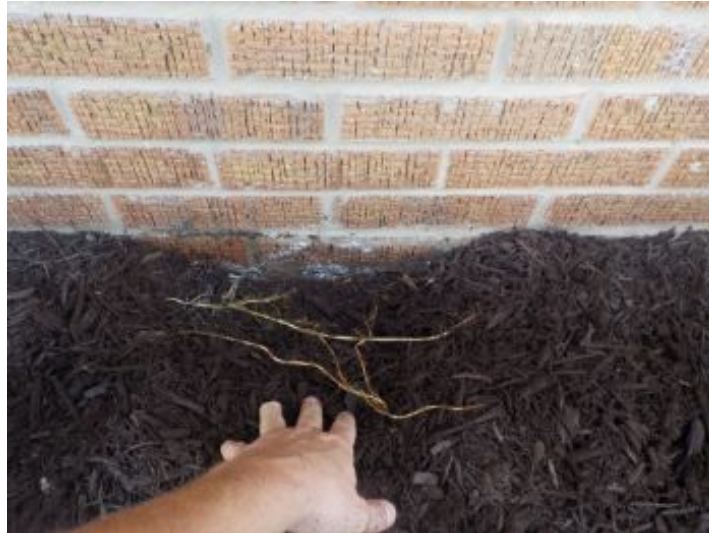
5" or 6" mulch built up to the brick, may cause moisture and water wicking into the brick.

- Observations: Satisfactory • 5" or 6" of mulch depth is noted on the driveway side of the home, this may lead to water retention and possible wicking into the brick.

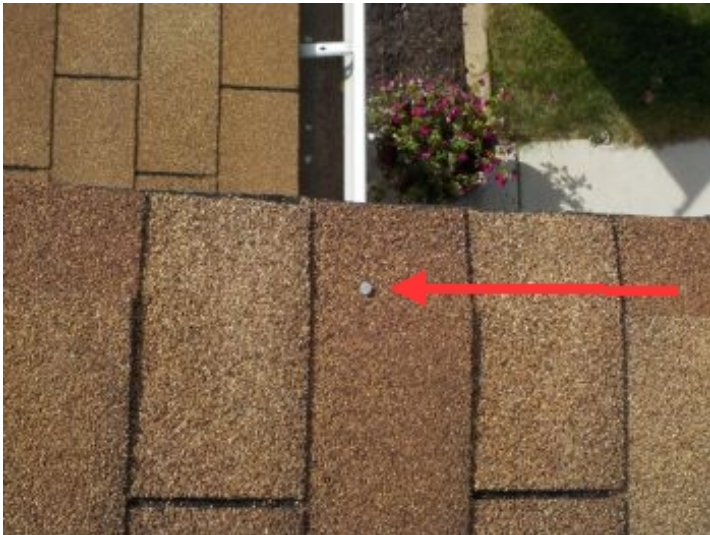
Exposed surface nails on roof vents should be covered with a sealant to ensure against water seepage, apply as needed

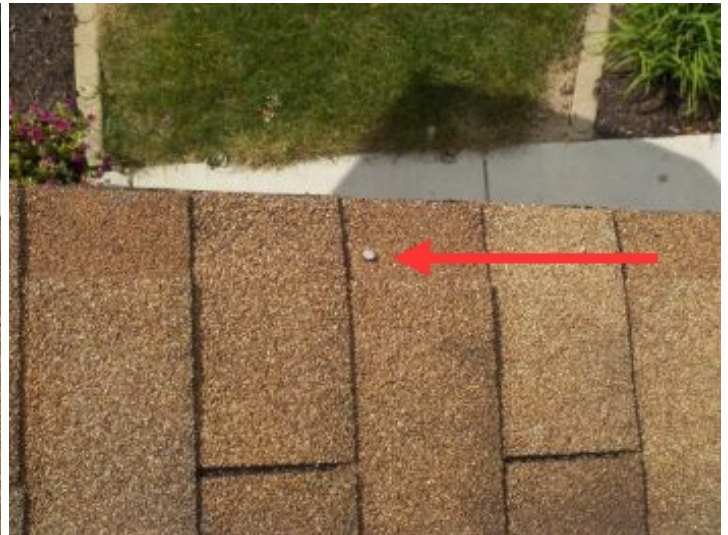
Exposed surface nails on roof vents should be covered with a sealant to ensure against water seepage, apply as needed

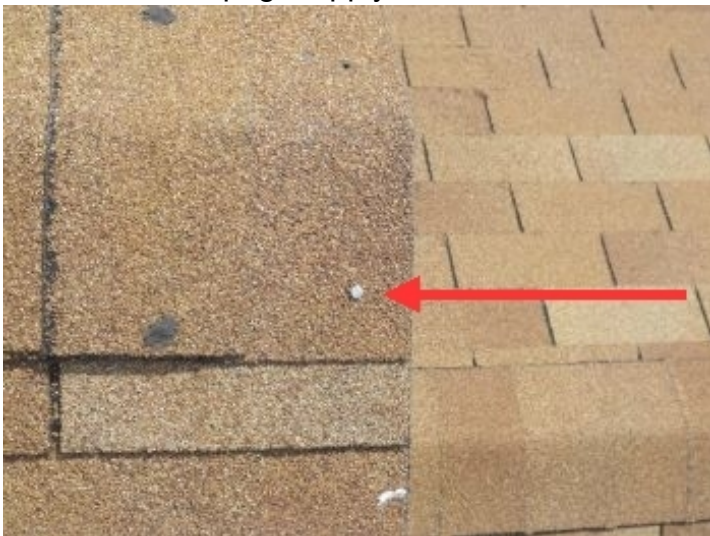
Exposed surface nails on roof vents should be covered with a sealant to ensure against water seepage, apply as needed

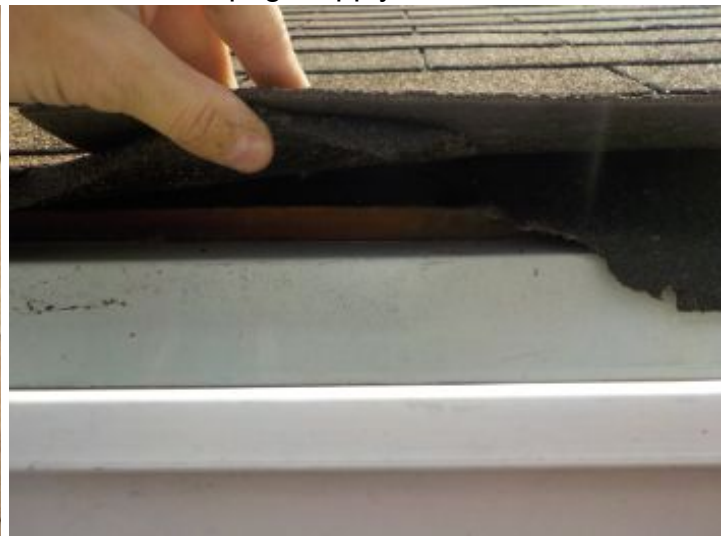
Drip Edge should be secured to the decking.

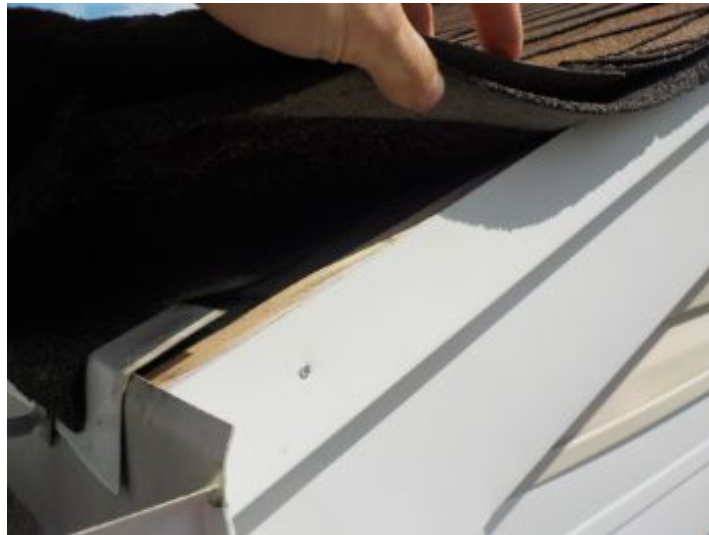
Drip Edge should be secured to the decking.

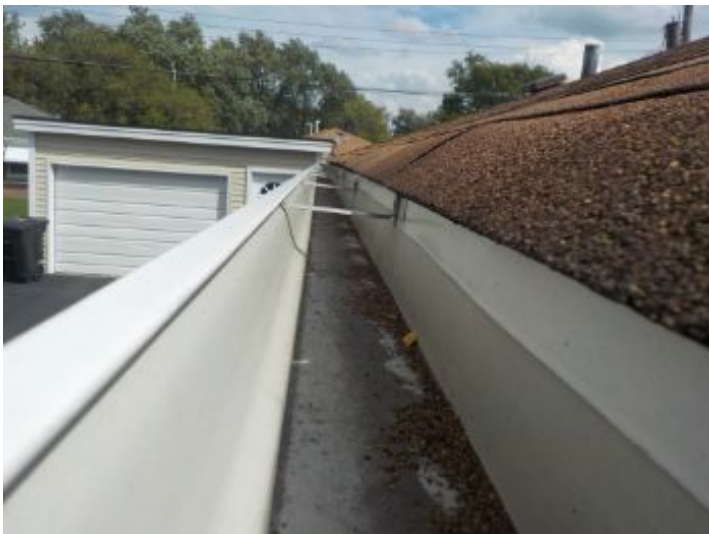
some granule loss in the gutters.

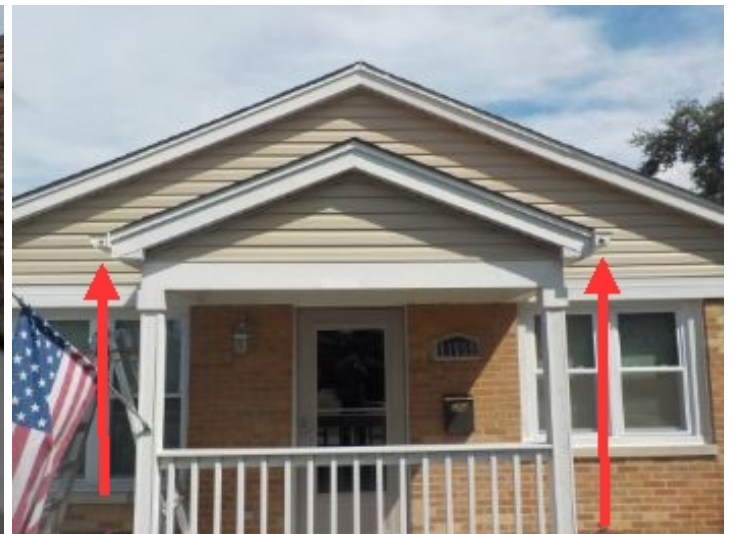
No Gutters.

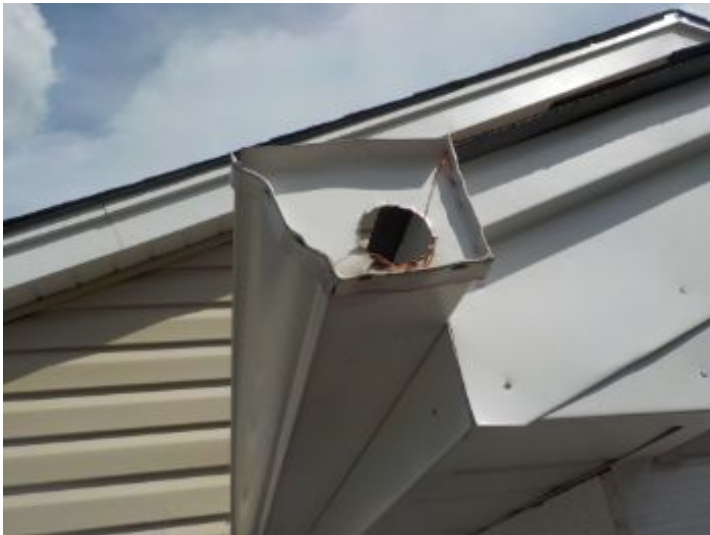
Front Canopy No Gutters.

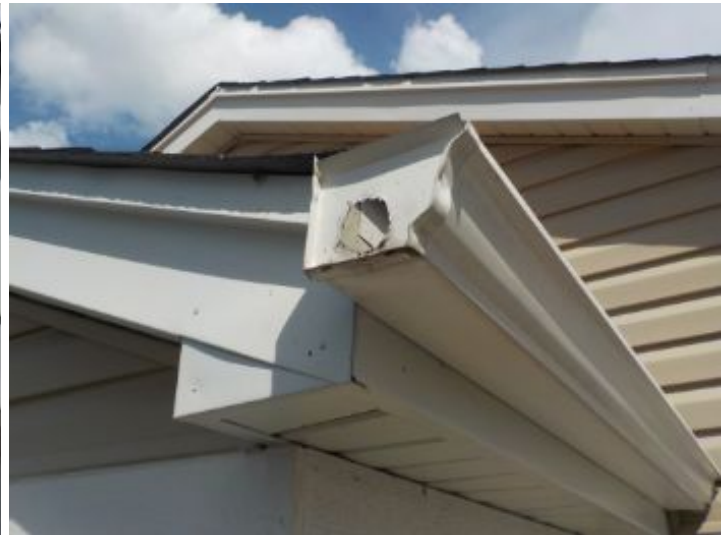
Front Canopy, No Gutters.

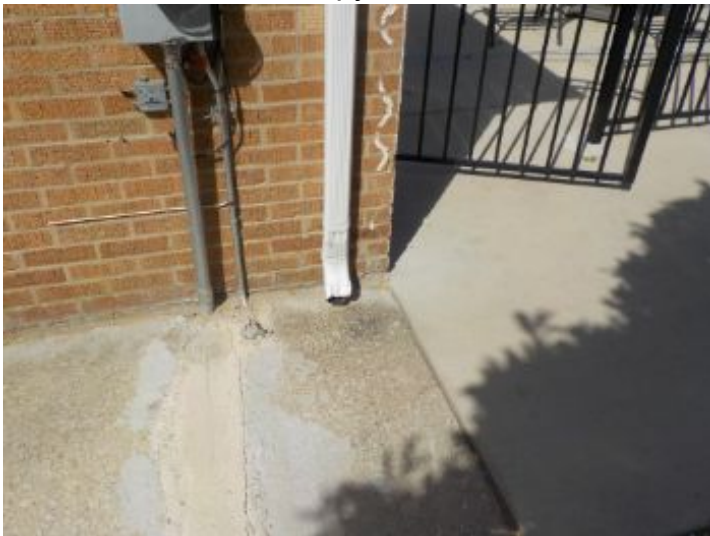
Down spot should extend 6' away from the property.

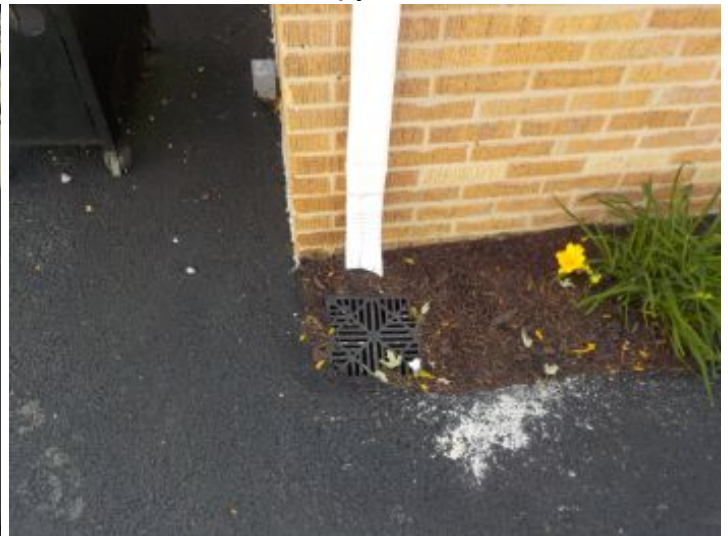
Driveway, Downspout, unable to to locate the end of the drain.

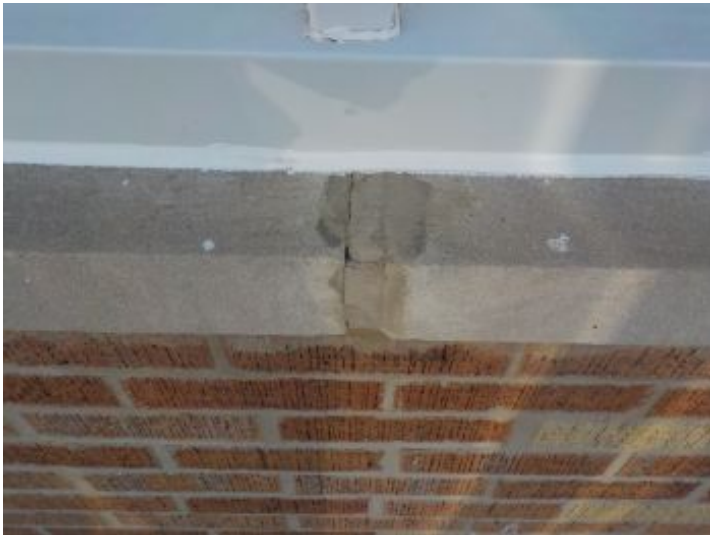
Hairline crack in window sill, recommend repairs to prevent water intrusion.

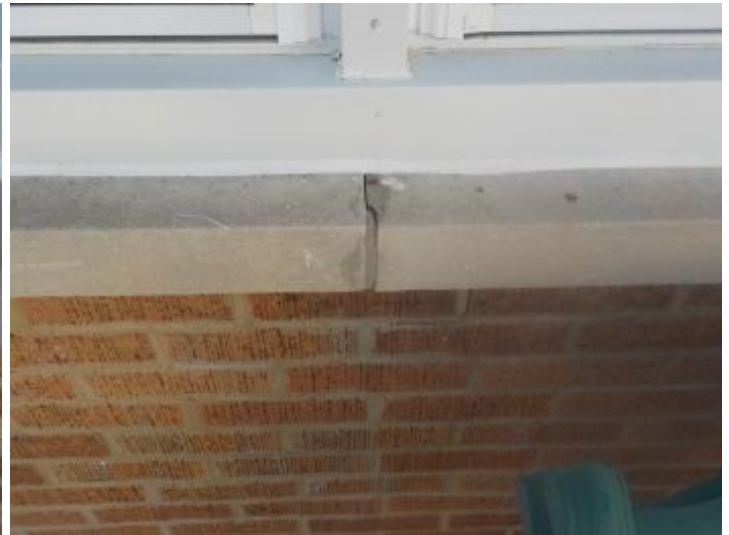
Hairline crack in window sill, recommend repairs, to prevent water intrusion.

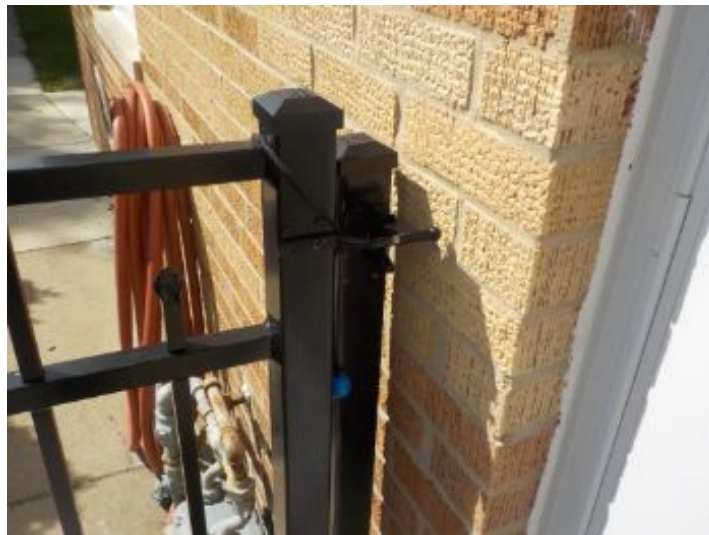
- Iron entry gates locking latch does not close smoothly.

Gate does not close freely.

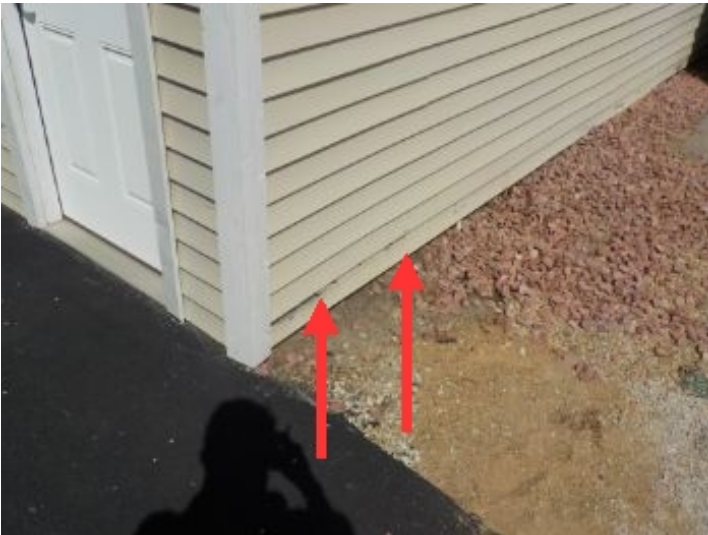
Garage, damage to the siding, may lead to moisture intrusion

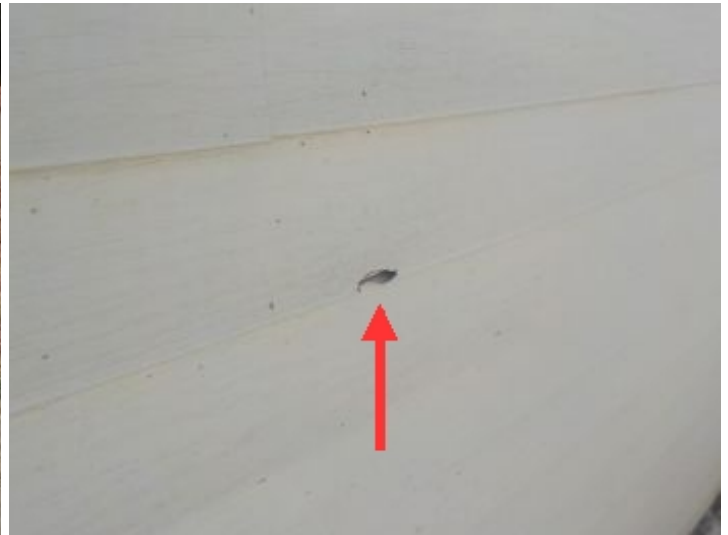
Garage, damage to the siding, may lead to moisture intrusion

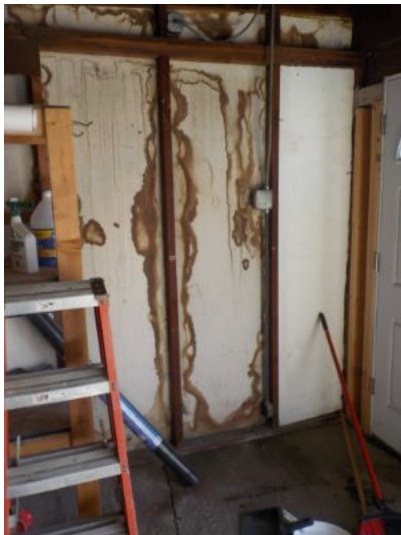
Garage, Evidence of moisture

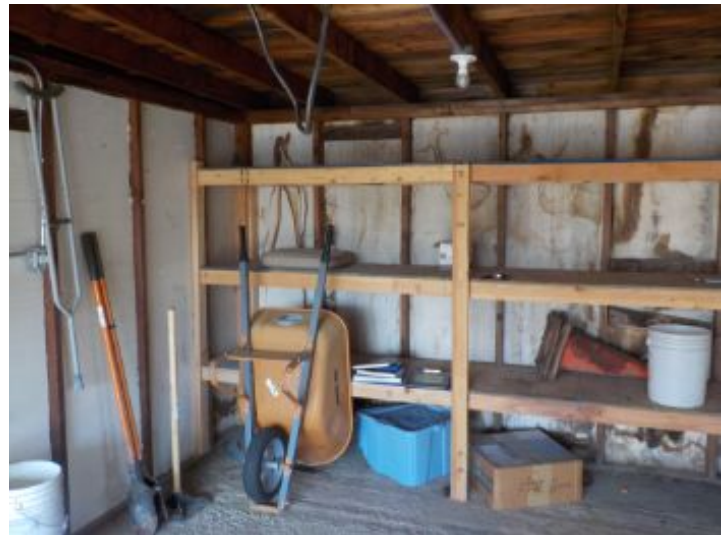
Garage, Evidence of moisture

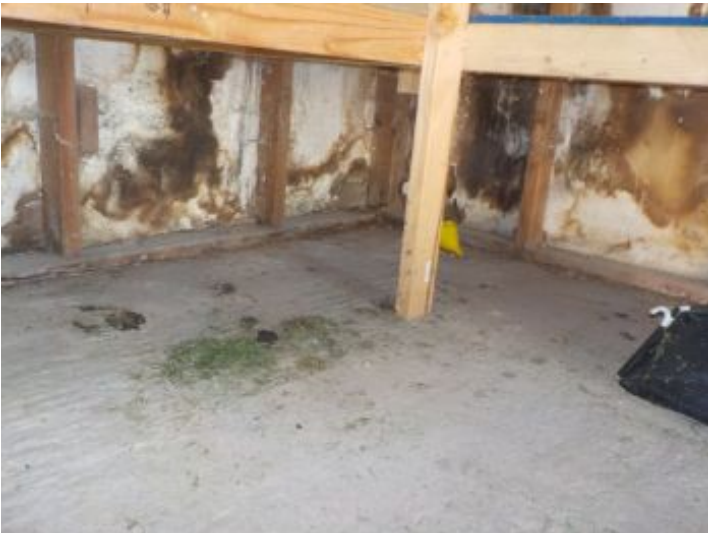
Garage, Evidence of moisture

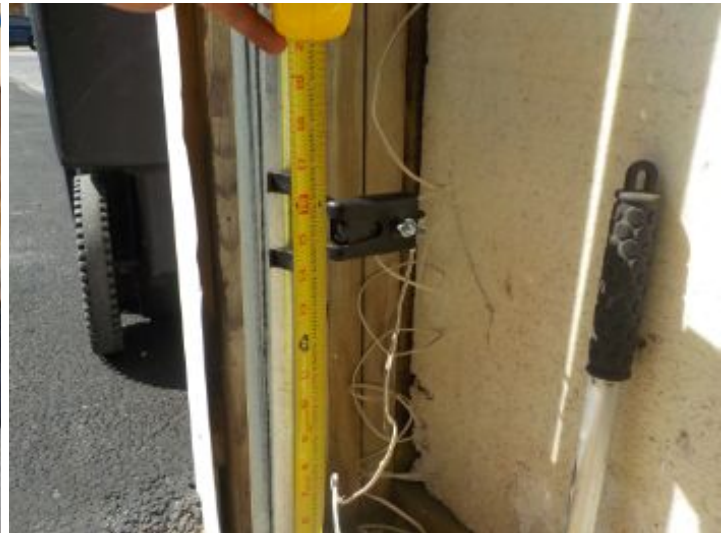
Garage door eye should be installed between 4"-6" from the slab.

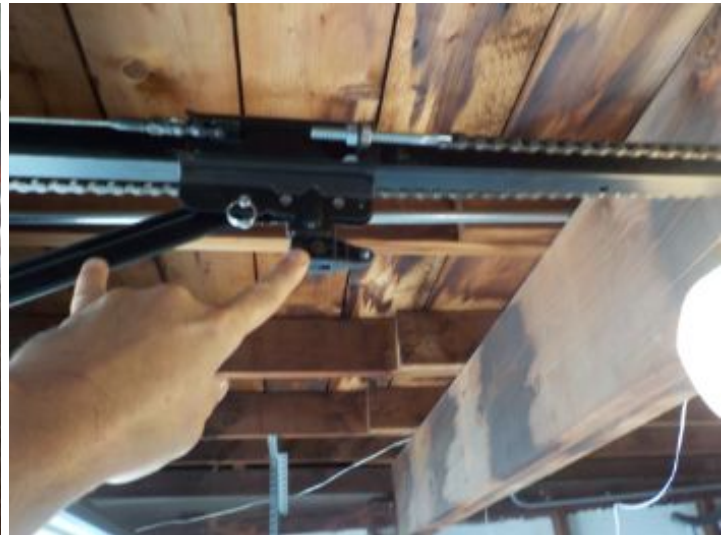
No manual string installed.

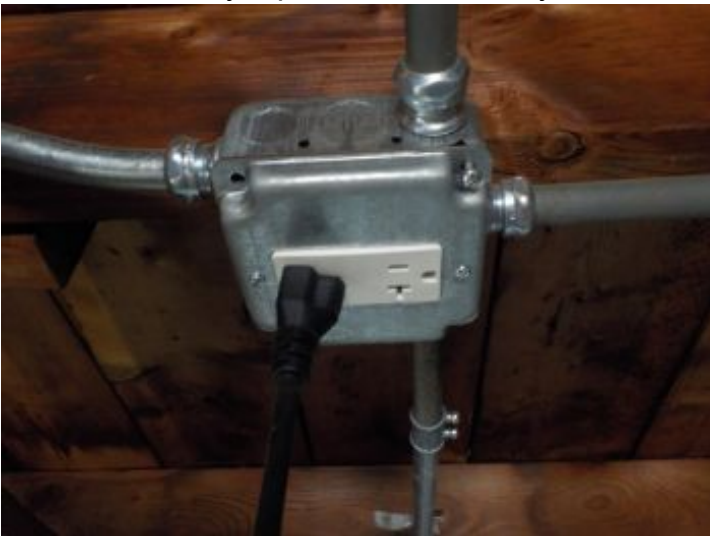
Garage, install a GFCI

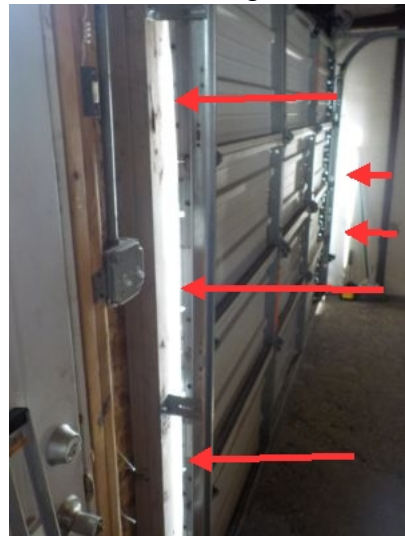
Garage door, should be butted up to the wall. Water, moisture, wind, snow, rodents can enter the garage.

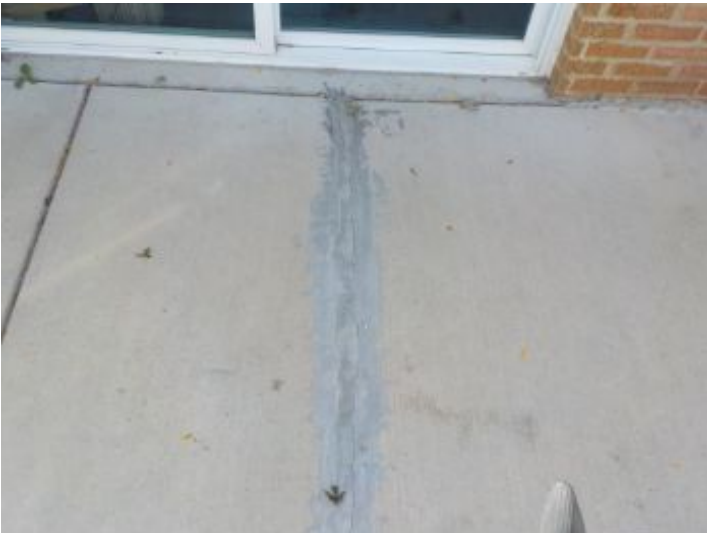
Patio, small hairline crack in the concrete.

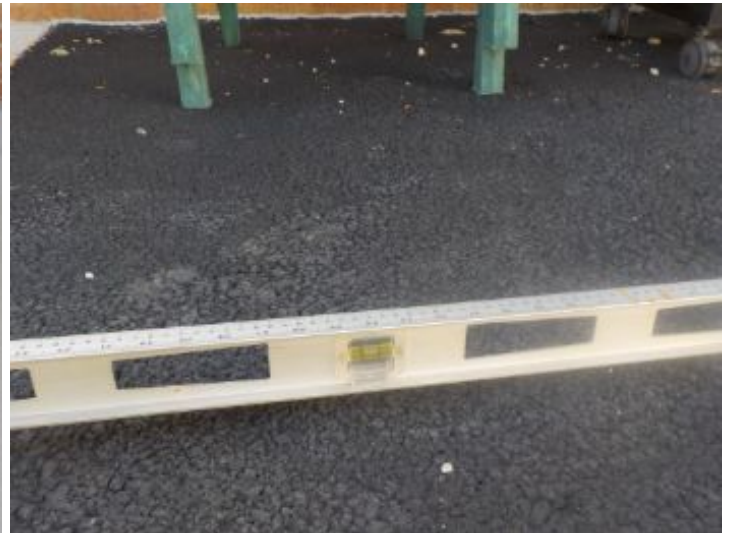
Patio, small crown that may lead to water pooling towards the home.

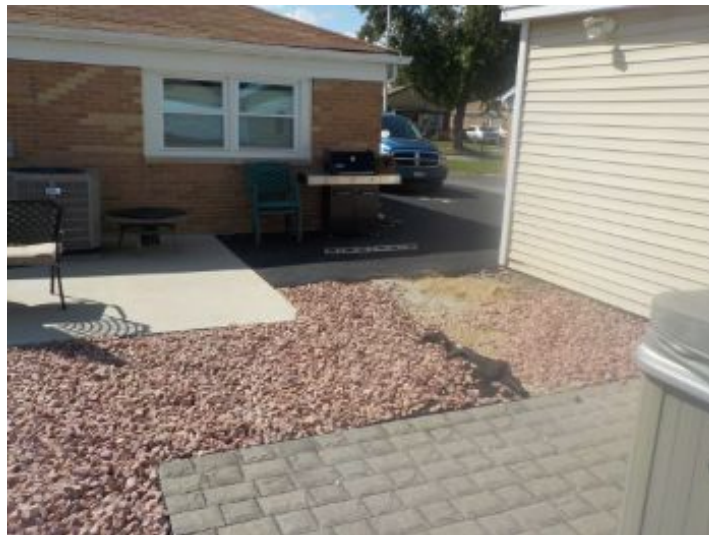
Patio, small crown that may lead to water pooling towards the home.

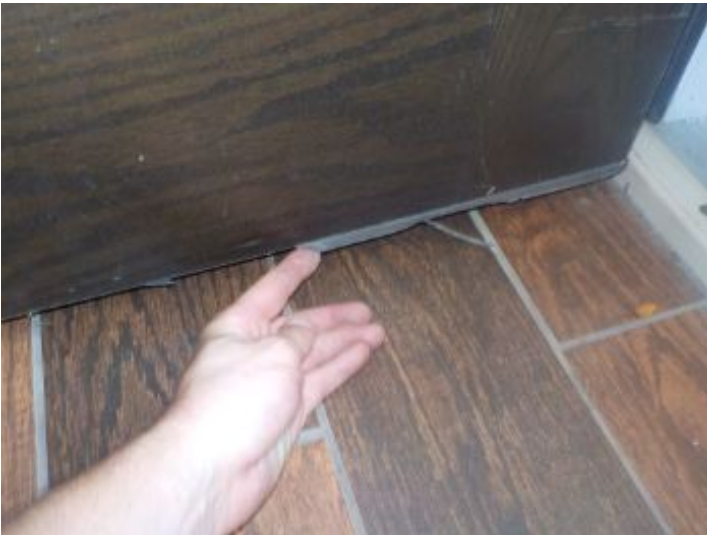
front door, weather stripping damaged.

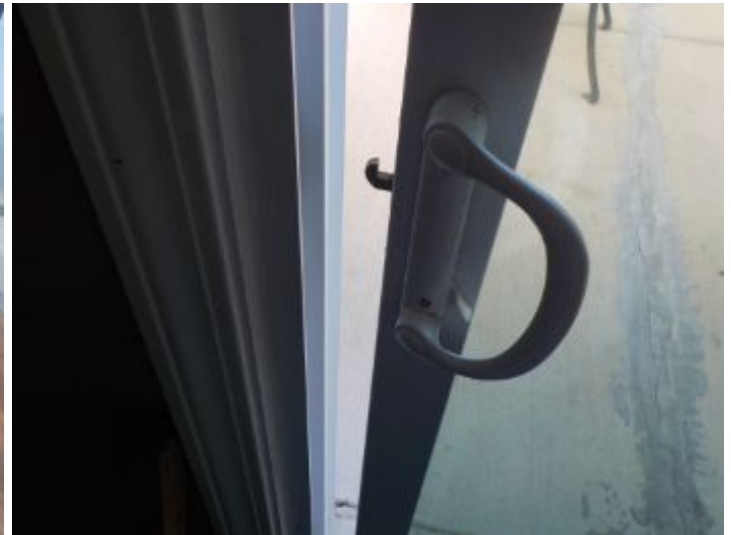
Bedroom door does not secure properly, recommend repairs.

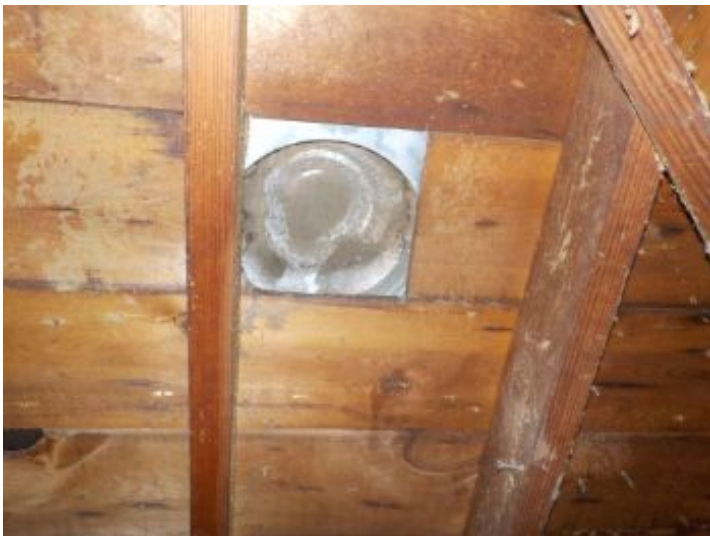
Attic vent dirty , should be cleaned on a regular basis.

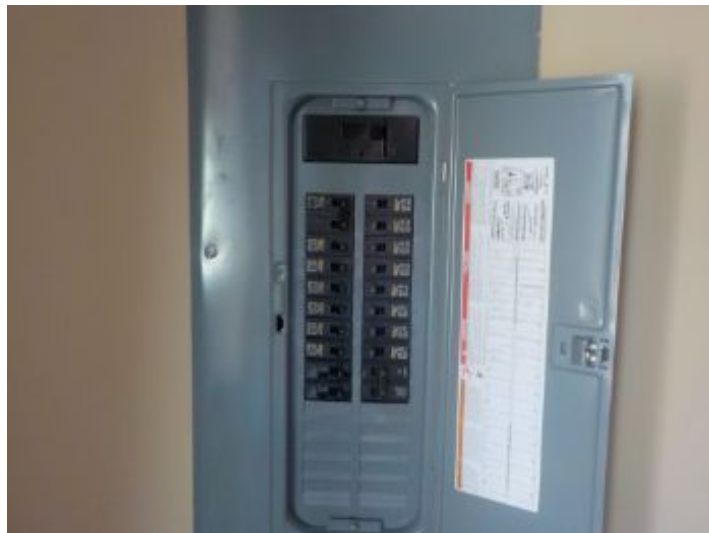
- Appears satisfactory
- Main panel needs complete labeling to identify power distribution of each breaker

200 amp panel, located in the BD #1, not all breakers labeled

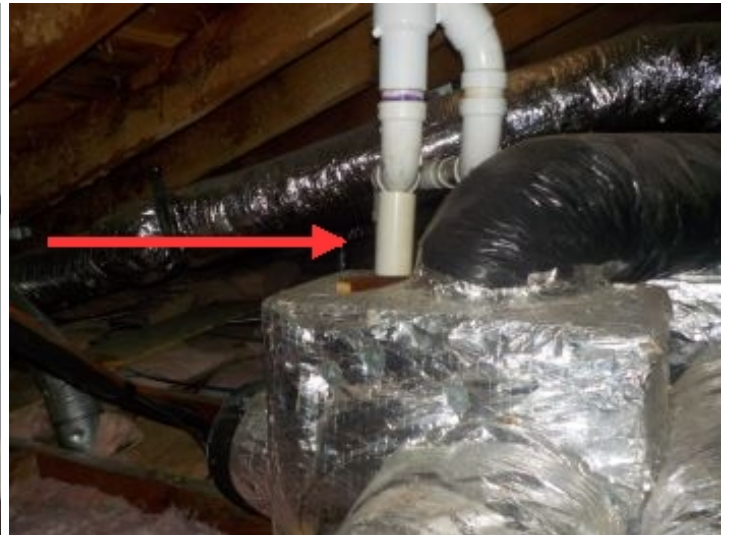
Attic, vents lines from the furnace, ( not the best practice)

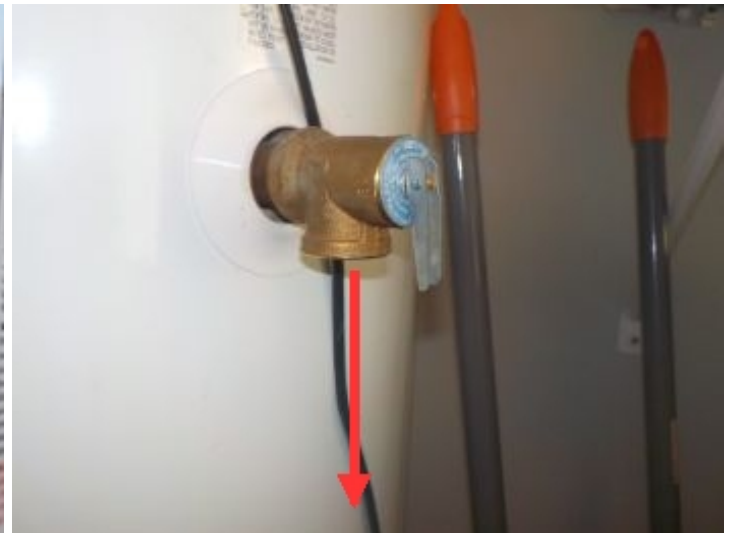
- Operated satisfactory
- Water heater lacks a temperature pressure relief discharge line, this line should extend to within 9 inches of the floor
- Water heater pan is not connected to a drain, if heater was to leak into pan water would overflow in pan causing damage to lower level

Pressure Relief Valve, pipe line should extend to the floor.
